NATIONAL FLOOD INSURANCE PROGRAM

FIRM ORIGINAL
FLOOD INSURANCE RATE MAP

YAVAPAI COUNTY,
ARIZONA AND
INCORPORATED AREAS

PANEL 1810 OF 3925

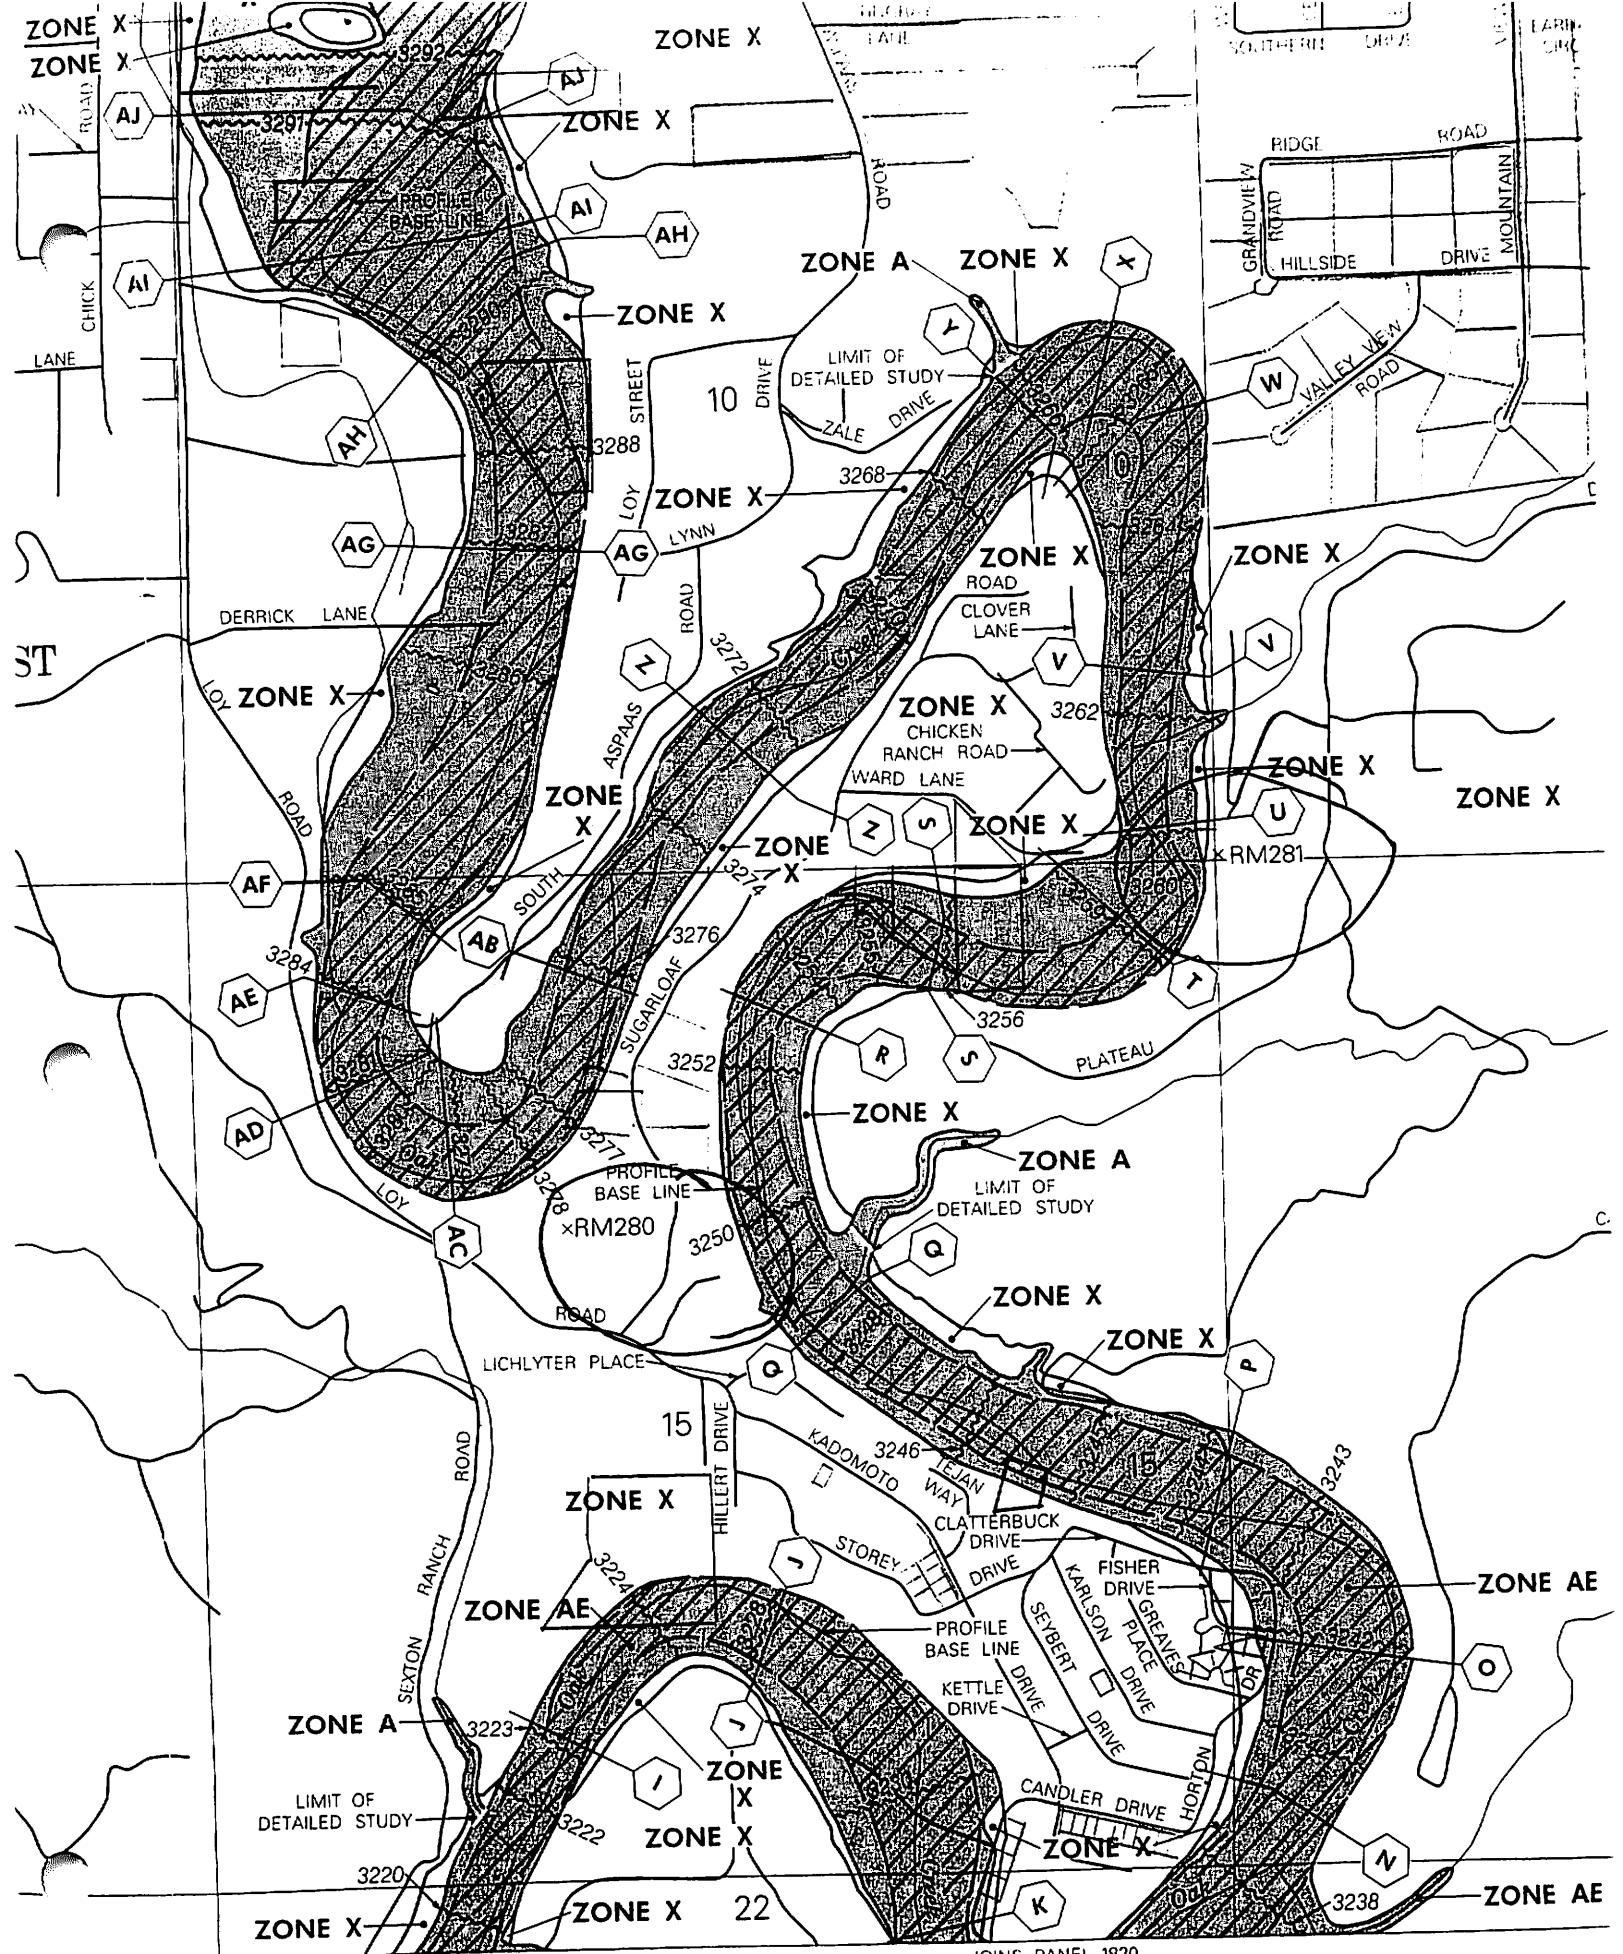
MAP NUMBER
04025C1810 F

ELEVATION REFERENCE MARKS

RM281	3264.71	U.S. Department of Interior Bureau of land management brass cap, in 4-inch diameter soil pipe stamped "T15N, R4E 1964", approximately 69 feet south of dirt road centerline and approximately 110 feet east of a power pole with transformer and approximately 80 feet southeast of a 12 foot high power pole and approximately 69 feet south of a metal gate and approximately 3 feet southeast of fence corner and at the joining corners of Sections 10, 11 15 and 14.
-------	---------	---
