NATIONAL FLOOD INSURANCE PROGRAM

FIRM *SE OFFICIAL*
FLOOD INSURANCE RATE MAP

**YAVAPAI COUNTY,
ARIZONA AND
INCORPORATED AREAS**

**MAP NUMBER
04025C0955 F**

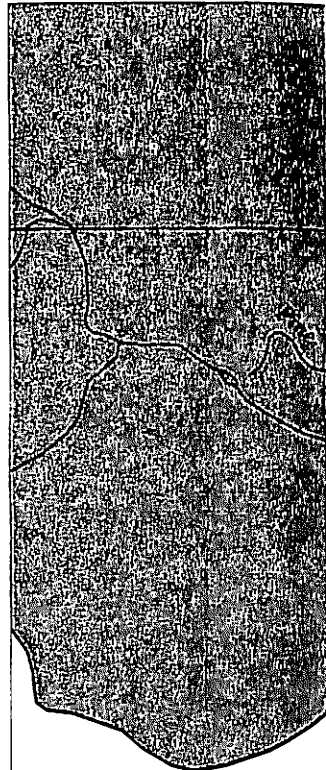
ERM: 201
Panel: 955

ELEVATION REFERENCE MONUMENT

Elevation (NAVD88): 4464.49

Elevation (NGVD29): 4461.71

Latitude: 34°57'25" N
Longitude: 112°34'37" W

Description: Top of 3 inch aluminum cap in concrete, 0.2 foot above natural ground. Commencing at the Paulden Post Office, then north on U.S. Highway 89 approximately 0.7 mile to Big Chino Road, then west or left on Big Chino Road approximately 9.2 miles to Y in road, then west or left approximately 0.2 mile to fence and cattle guard, then south or left approximately 1.1 miles to fence, then west or right along fence approximately 500 feet to power line, then north 30 degrees west along power line approximately 0.3 mile to 5th pole, then south 50 degrees west approximately 54 feet to monument.

RM201 4461.71 Top of 3 inch aluminum cap in concrete, 0.2 foot above natural ground. Commencing at the Paulden Post Office, then north on U.S. Highway 89 approximately 0.7 mile to Big Chino Road, then west or left on Big Chino Road approximately 9.2 miles to Y in road, then west or left approximately 0.2 mile to fence and cattle guard, then south or left approximately 1.1 miles to fence, then west or right along fence approximately 500 feet to power line, then north 30 degrees west along power line approximately 0.3 mile to 5th pole, then south 50 degrees west approximately 54 feet to monument.

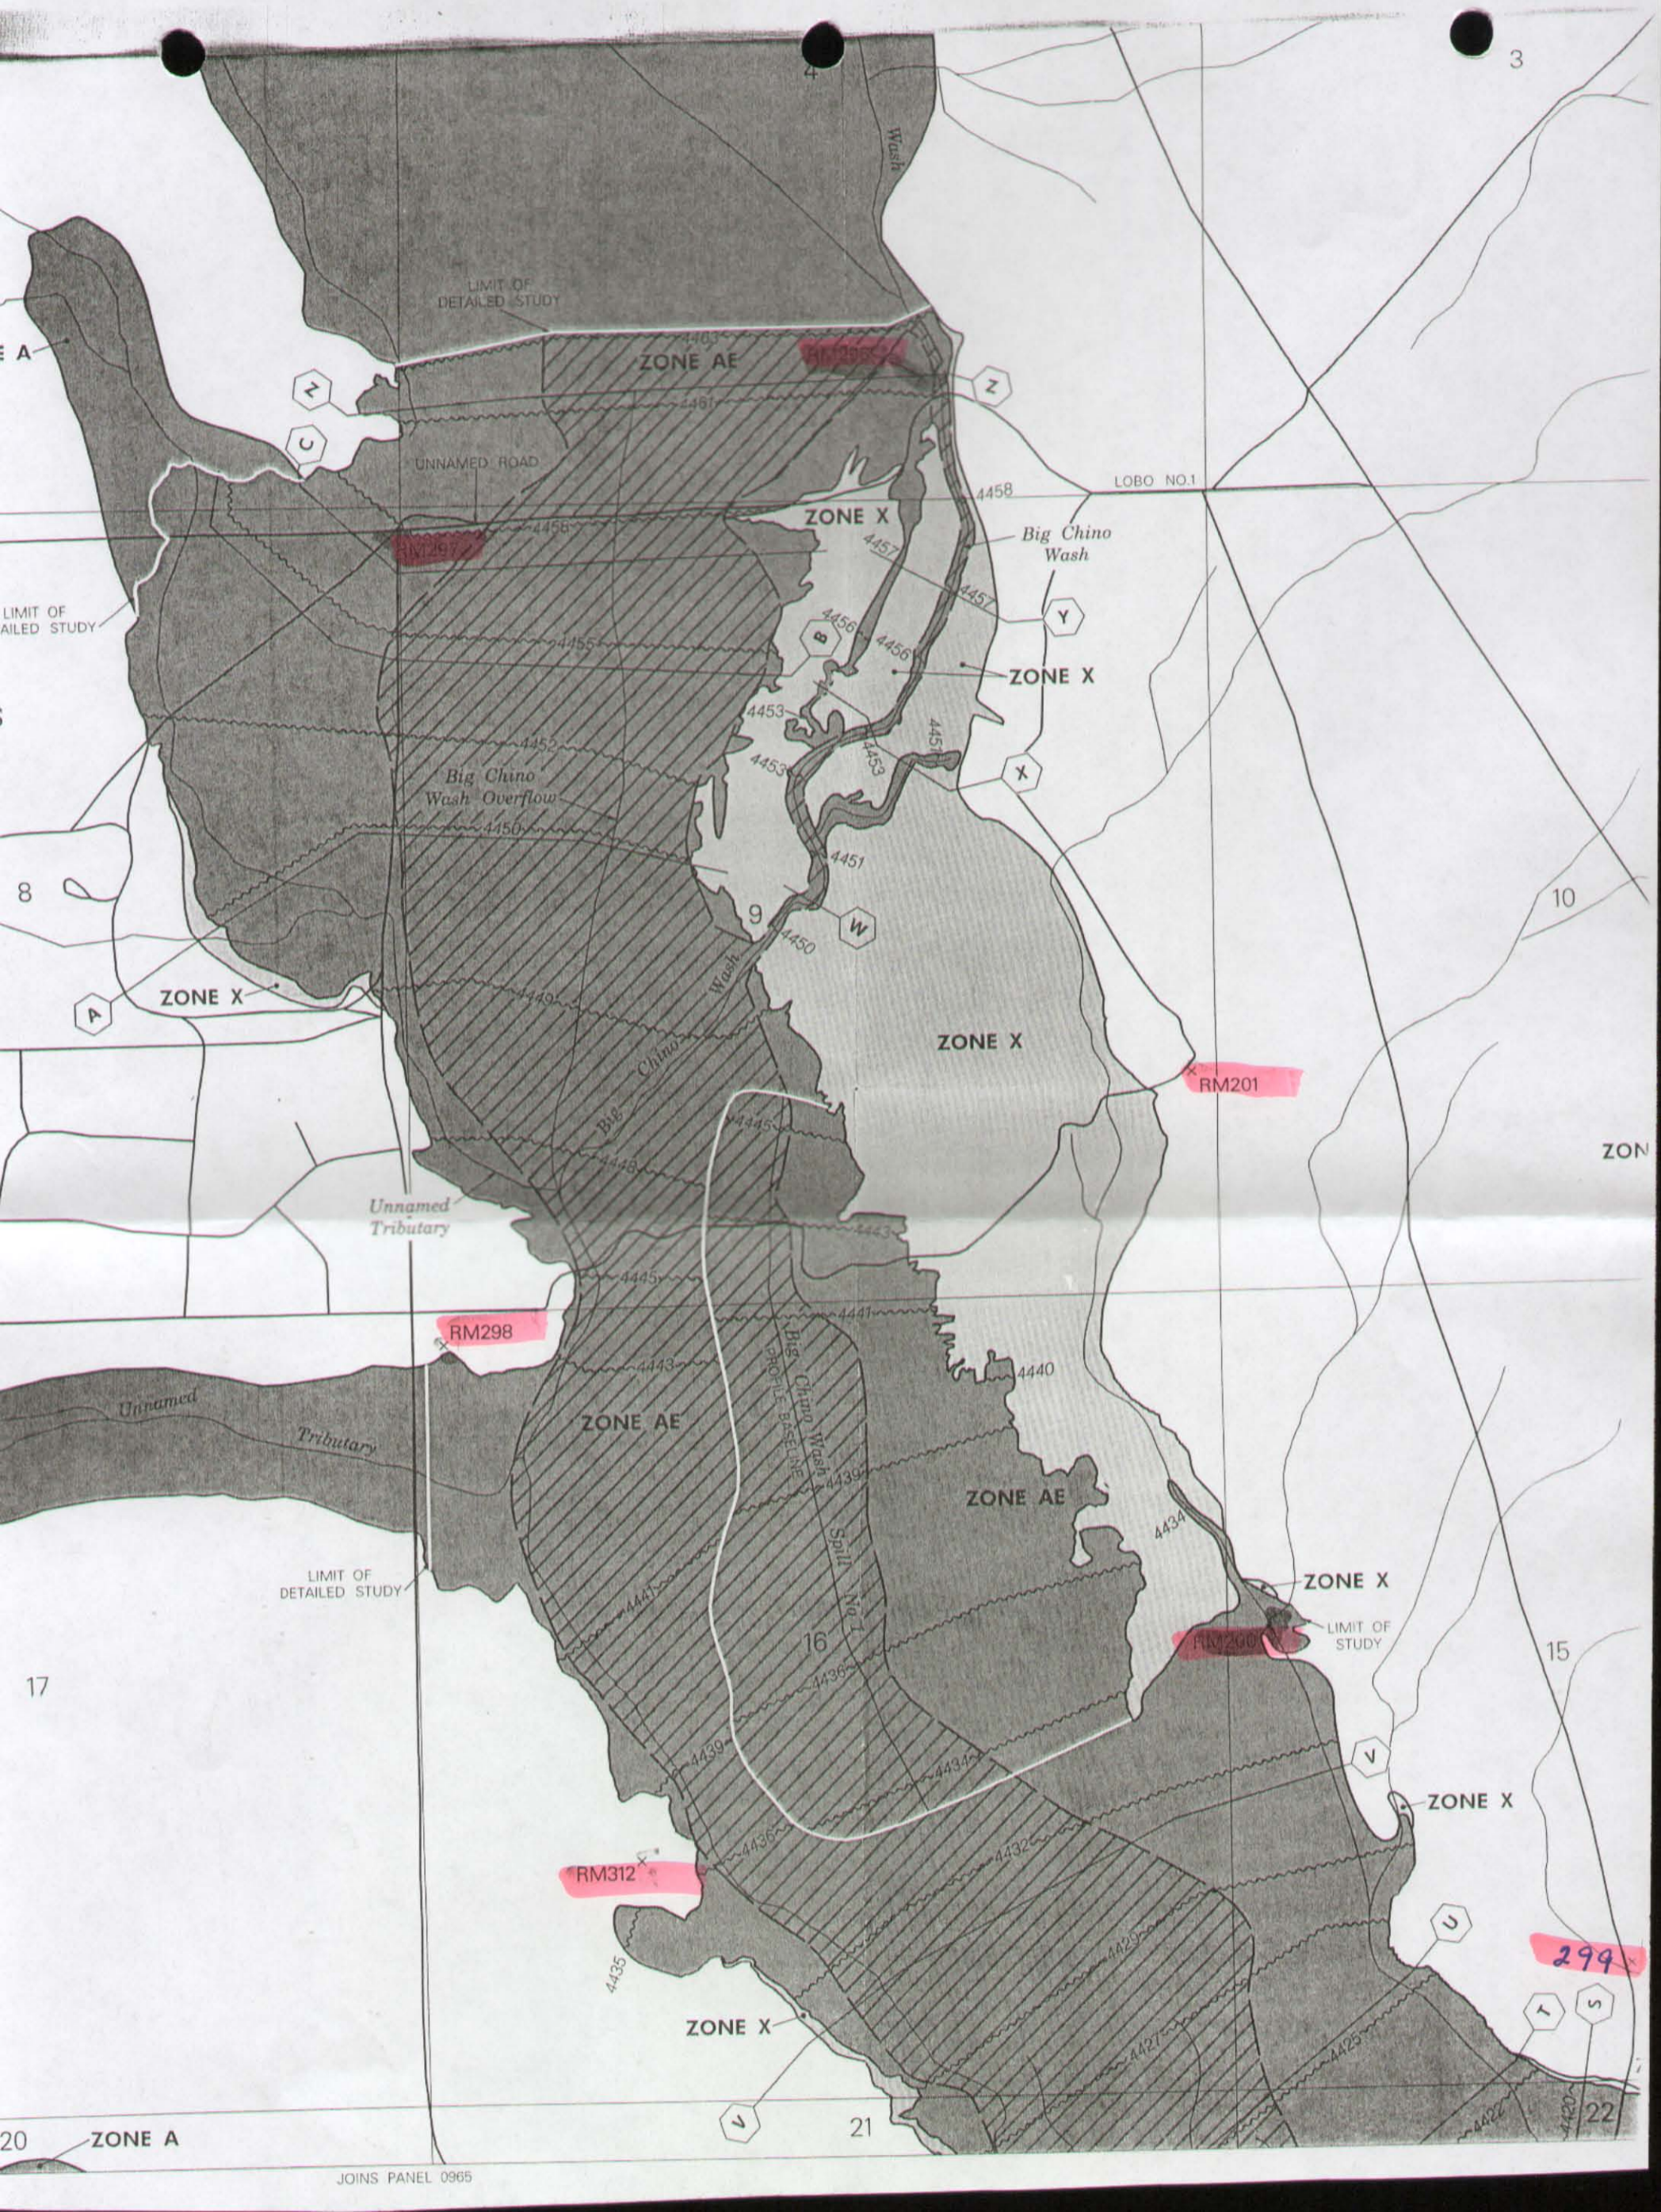
PANEL 955 OF 3925

**EFFECTIVE DATE:
JUNE 6, 2001**

LIMIT OF DETAILED STUDY

ZONE AE

Big Chino Wash

Big Chino Wash Overflow
